EXPERIMENTAL STUDY OF STRENGTHENING OF RC CONTINUOUS BEAM USING FRP COMPOSITES

Chennadi Kavya Sree¹, B. Sumalatha² and Dr. B. Sharath Chandra³

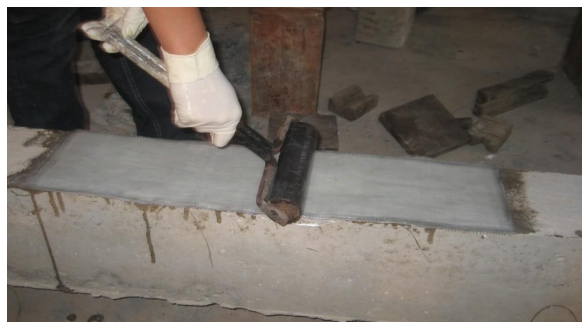
Before bonding the fiber, the concrete surface is roughened with coarse sandpaper and thoroughly cleaned with an air blower to remove any dirt or particles. The fiber textiles are then precisely cut to the required size, and the epoxy resin is prepared according to the manufacturer's instructions. Specifically, Araldite LY 556 and Hardener HY 951 are mixed in a 100:10 weight ratio in a plastic container. Once the epoxy glue is thoroughly mixed, it is applied to the prepared concrete surface. The GFRP sheet is then carefully placed over the epoxy coating, and a roller is used to press the resin through the fabric's roving, ensuring the removal of any trapped air bubbles. The process begins by roughening the concrete surface with coarse sandpaper, followed by cleaning with an air blower to eliminate dirt and particles. After cutting the fiber textiles to the correct size, the epoxy resin, made by mixing Araldite LY 556 and Hardener HY 951 in a 100:10 weight ratio, is applied to the concrete. The GFRP sheet is placed over the epoxy coating, and the resin is rolled through the fabric's roving to ensure proper impregnation and expel any trapped air bubbles.

Figure 3.4 Application of epoxy and hardener on the beam.

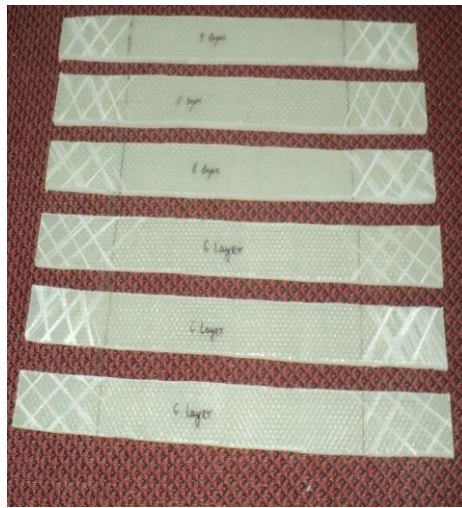
Figure 3.8 Specimens ready for tensile testing

To determine the ultimate stress, ultimate load, and Young's modulus, a unidirectional tensile test was conducted on specimens taken from the plates in both the longitudinal and transverse directions. Table 3.4 presents the measurements of these samples. The specimens were cut from the plates using either a diamond cutter or a hex saw, and they were subsequently polished using a polishing machine.

The INSTRON 1195 universal tensile test device was used to subject the specimens to failure at a predefined rate of extension in order to measure Young's modulus. Initially, the specimens were held by the upper jaw of the device, followed by the lower movable jaw. To ensure a secure grip and prevent slippage, the specimen was tightly held, with a 50 mm gauge length on each side. The strain was initially set to zero. Load and extension were digitally recorded using a load cell and an extensometer, respectively. This data was used to create a stress versus strain graph, with the Young's modulus determined from the initial slope of the graph. The final stress and load at the point of specimen failure were also determined. The average values for each layer of specimens are presented in Table 3.4.

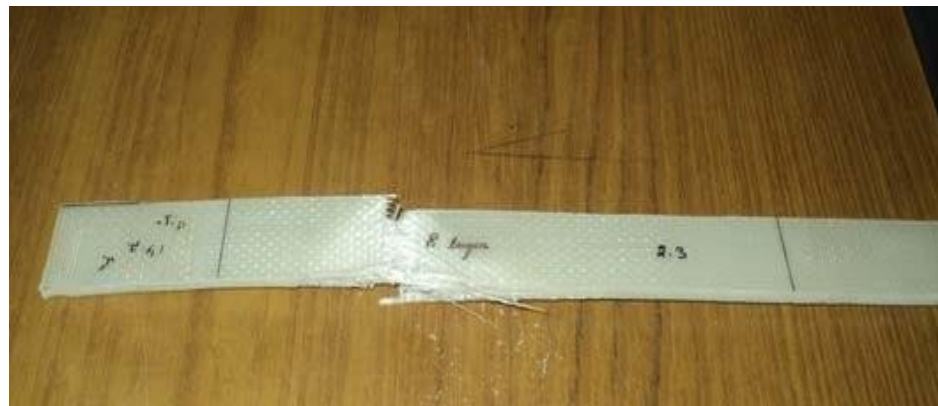
Figure 3.10 Specimen failure after the tensile test

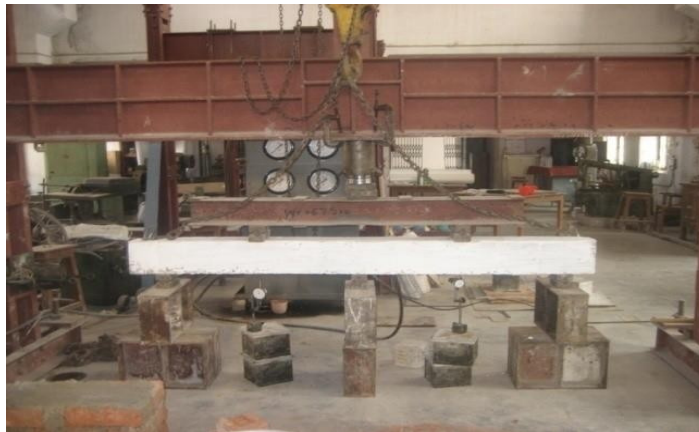
Figure 3.11 Experimental Setup of the C.B1

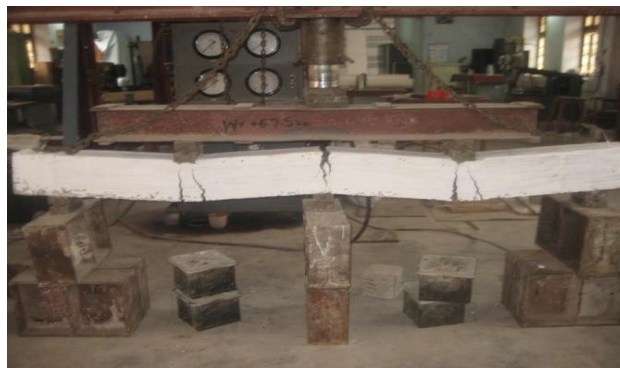
CB1 failed in the conventional RC flexural mode due to the internal tensile steel reinforcement of the control beam. Significant flexural cracks developed at the mid-span and central support, extending deep into the compressive zones.

Figure 3.12 Flexural failure of C.B1

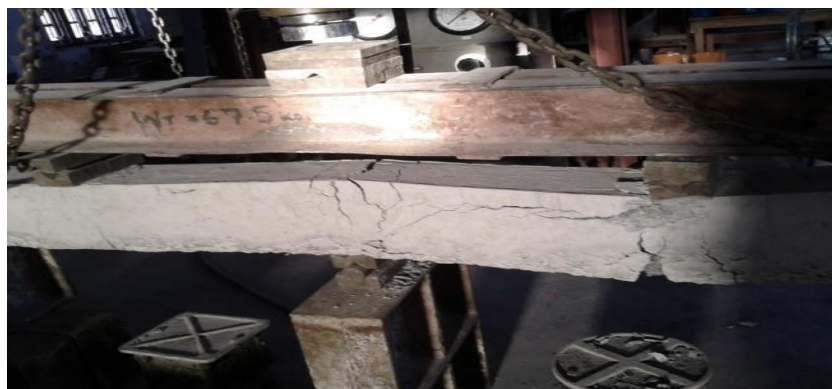
The control beam, CB2 also failed in flexural failure as shown in Figure 3.13.

Figure 3.13 Control Beam, C.B2 after failure

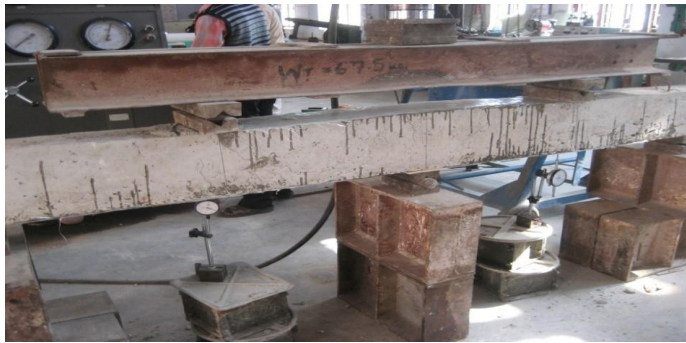
The beam was reinforced by applying six layers of FRP above the central support and two layers of FRP underneath the beam (each 150 mm wide) between two load locations, as depicted in Figure 3.14. As shown in Figure 3.15, the reinforced beam SB1 began to crack at a load of 110 KN and ultimately failed at 320 KN due to a debonding failure, where the FRP sheet detached from the concrete cover. The sudden rupture of the FRP sheet and the accompanying loud noise indicated a rapid release of energy and a complete loss of load capacity.

Figure 3.14 Experimental Setup of the Beam

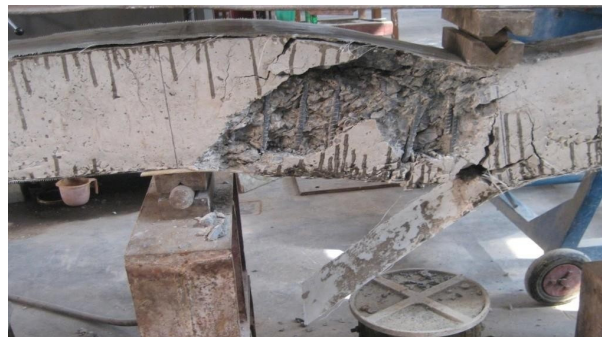
Figure 3.16 Magnified view of the failure of the beam

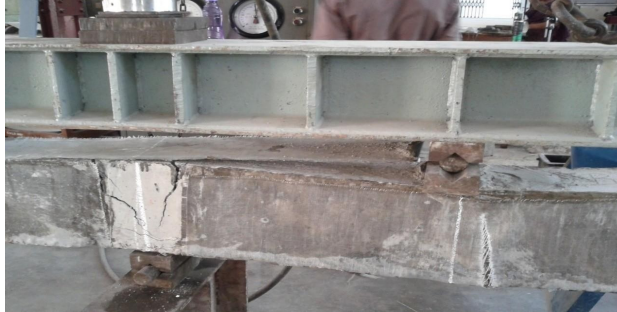
A single layer of U-wrap was applied to the beam to prevent flexural failure. Tensile rupture occurred at the center of both the left and right sides of the FRP.

Figure 3.17 Tensile rupture of FRP at mid-section of right span at lower value

Figures 3.17 and 3.18 show how the beam failed in deboning with a concrete cover at low loads and developed a shear crack under the FRP covering as the load increased.

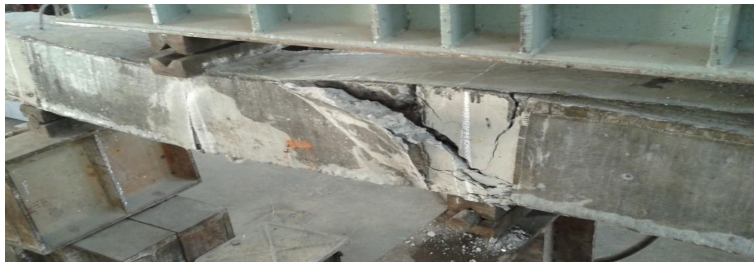
Figure 3.18 Ultimate failure of beam by deboning of FRP with concrete Cover

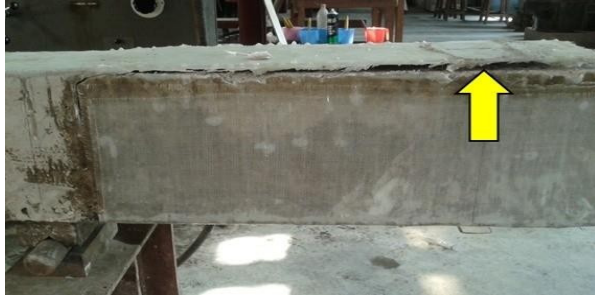
To boost the load capacity, U-Jacketed double Layered GFRP was employed, as shown in Figure 3.19. By strengthening the beam with GFRP sheet, cracking of the RC beam may be delayed and flexural capacity increased. When the FRP sheet was deboned, the reinforced beam collapsed (Figure 3.20).

Figure 3.19 U-jacketed GFRP wrapped on the Beam SB3

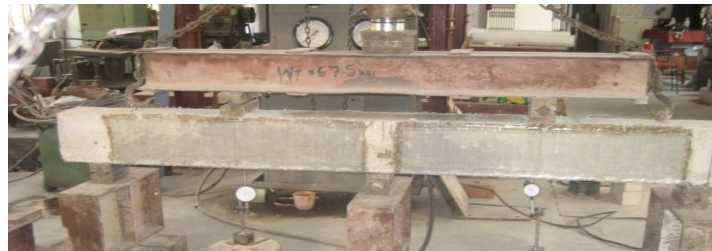
Figure 3.20 Debonding failure of FRP

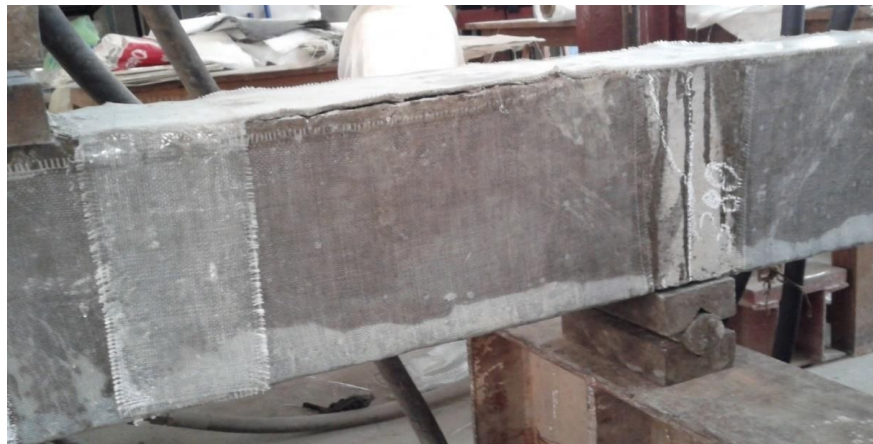
To prevent debonding, a full layer of U-wrap was applied over the two layers of FRP on the beam's soffit (150 mm wide), and a U-strip, 10 cm wide, was placed over the six layers of FRP above the central support. The failure mechanism was tensile rupture, and the U-strip failed to prevent the debonding of the upper FRP layer because it ruptured at higher load levels. However, the complete U-wrap successfully supported additional weight and prevented debonding.

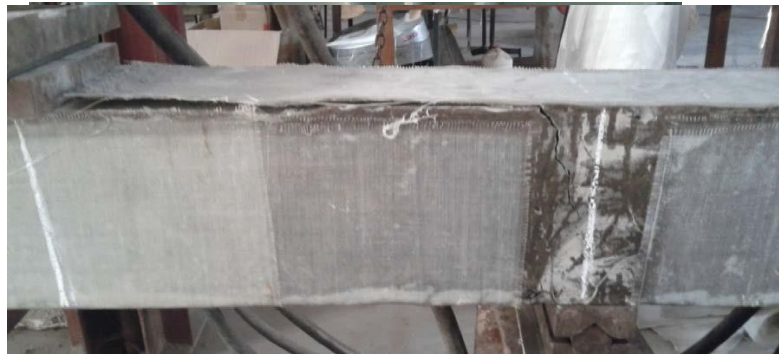
Figure 3.22 Crack pattern after initial loading

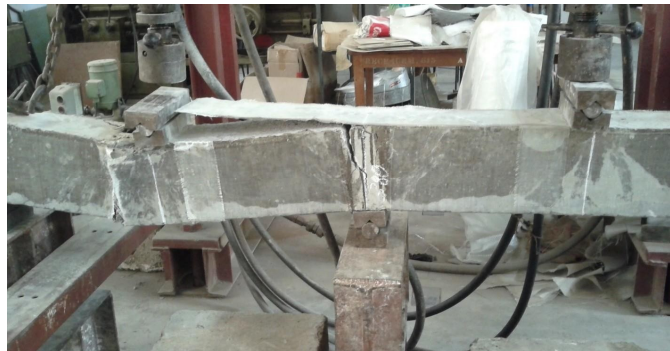
Figure 3.23 Failure of the beam by tensile rupture

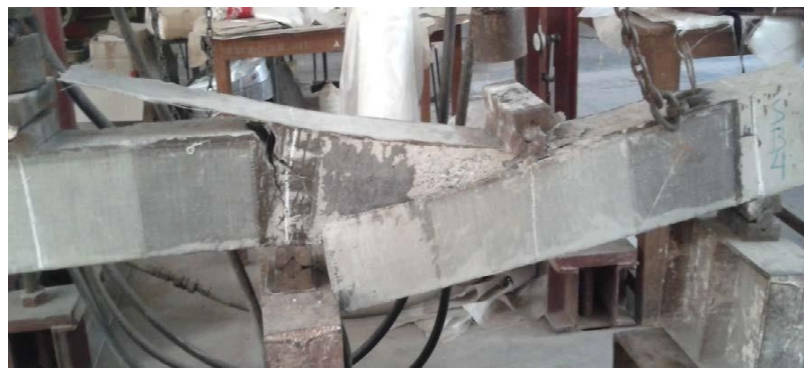
To avoid flexural failure, another two layers of FRP were put above the U-Jacketed double Layered GFRP in the flexural zone, but at half the width of the preceding two layers. Debonding failure occurred in this case rather than tensile rupture, as depicted. in Figure 3.27.

Figure 3.27 Deboning failure of Strengthened beam SB6

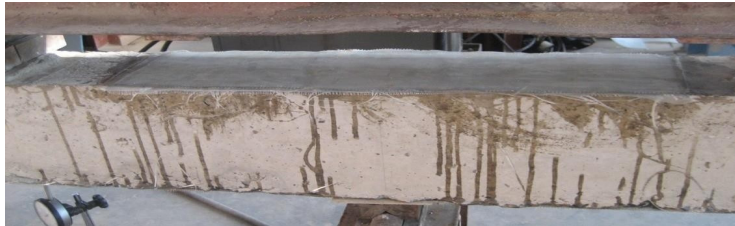
Figure 3.36 Top FRP of Beam TB1 before Testing

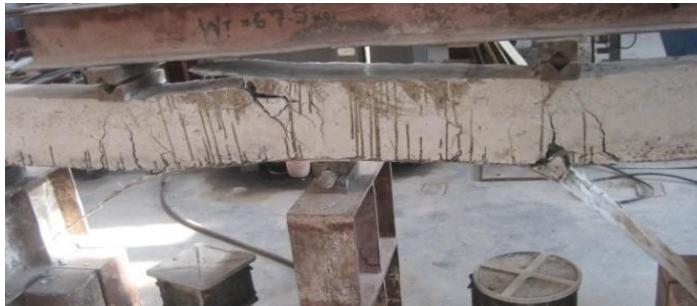
As shown in Figure 3.37, the reinforced beam initially fractured at a load of 110 KN and subsequently failed due to debonding at 224 KN, causing the FRP sheet to detach from the concrete cover. The sudden rupture of the FRP sheet and the loud noise it generated signaled a rapid release of energy and a complete loss of load-carrying capacity. Strengthening the beam with a GFRP sheet can delay cracking in the RC beam and increase its flexural capacity.

Figure 3.37 FRP sheet separations without concrete

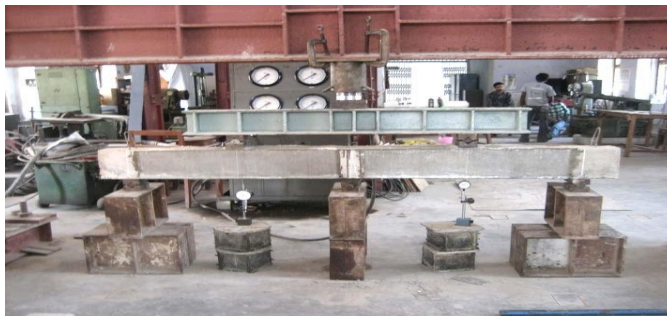
A full double-layered U-wrap and six layers of FRP above the core support were used. 298 KN was the ultimate failure load.

Figure 3.38 Experimental set up and strengthening pattern of TB2

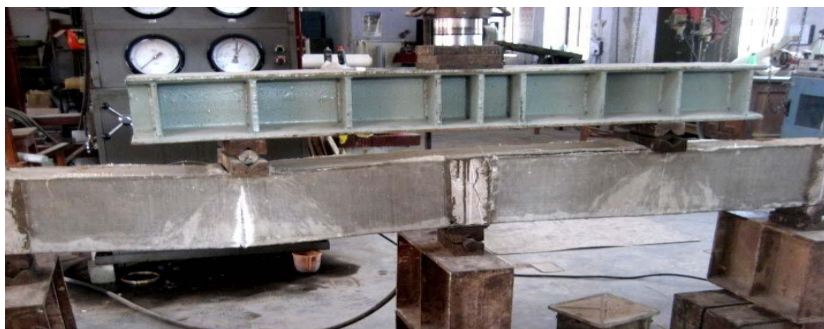
Figure 3.39 Failure of the beam by tensile rupture

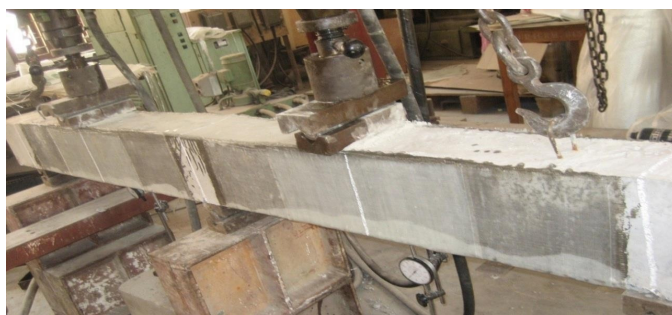
To prevent flexural failure, two more layers of FRP were put above the U-Jacked double Layered GFRP at the flexural fracture zone, but at half the width of the previous two layers. The failure type was deboning failure rather than tensile rupture, as seen in Figure 3.41, and the failure load was 326 KN.

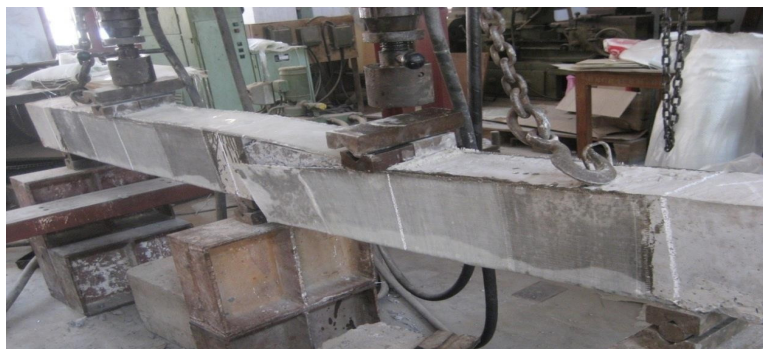
Figure 3.41 Failure of beam TB3

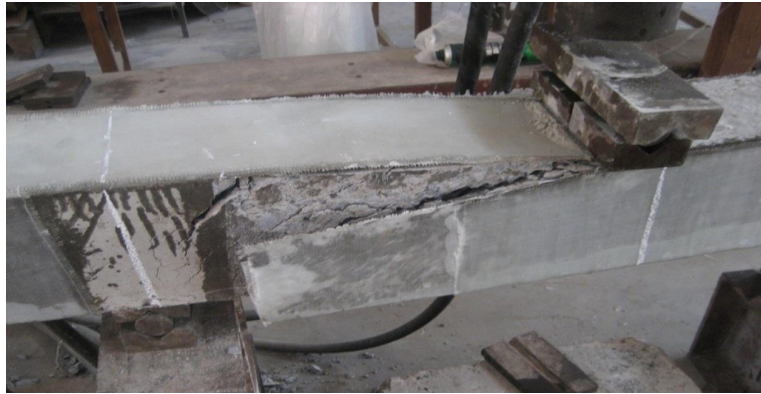
Figure 3.42 Shear crack in the left span

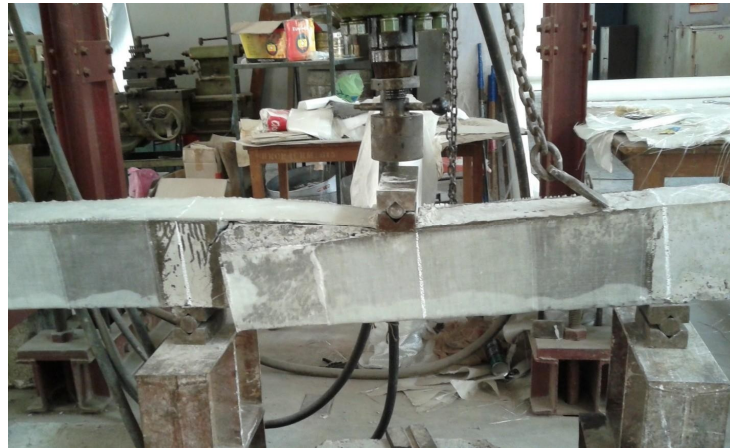
Figure 3.43 Failure mode of TB3

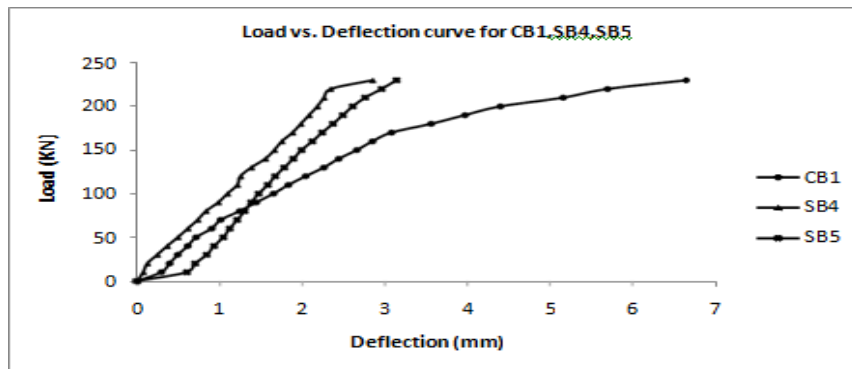
Figure 4.13 Load versus Deflection Curve for C.B1, S.B4, and S.B5

S.B4 was reinforced using one layer of U-wrap and U-strip, while S.B5 had two layers of U-wrap and two layers of U-strip added. Figure 4.13 illustrates a comparison of the mid-span deflections between these reinforced beams and the control beam.

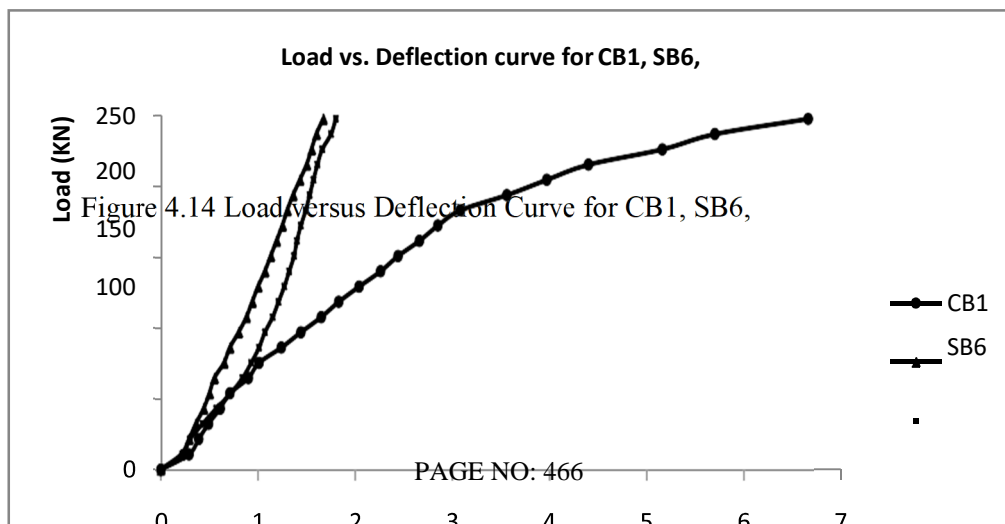
In the case of S.B7, G.F.R.P reinforcement in the form of U-wrap was applied in two layers below the neutral axis and four layers above it. S.B8 further increased the number of G.F.R.P layers to three below the neutral axis and six above it. The midpoint deflections of S.B1 and S.B8 were compared to that of C.B1. The graphs depicted in the figure indicate that by adding more G.F.R.P layers, the stiffness of the beam can be increased.

Figure 4.14 Load versus Deflection Curve for CB1, SB6,

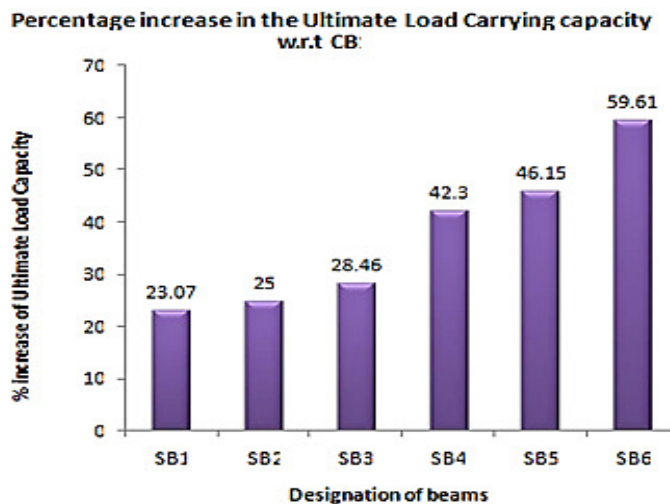
Figure 4.16 Percentage increase in the Ultimate Load Carrying capacity of beams of S1 w.r.t CB1

Figure 4.15 clearly illustrates that among all the reinforced beams in Series S1, SB6 exhibits the highest load capacity, while SB7 has the second-highest load capacity. On the other hand, Figure 4.17 provides a visual representation of the expected percentage improvement in load capacity for all the beams. From these figures, it can be concluded that the addition of GFRP to the beams can enhance their load capacity. Notably, SB6 beams show the largest percentage increase in load capacity among all the beams.
